# WHERE DID GENERAL MOTORS GO WRONG WITH THE IGNITION SWITCH RECALL?

ADNAN SHAOUD AND CASSANDRA DUSUTE

*Electrical and Computer Engineering Department, The University of Michigan - Dearbon  
Dearbon, MI 48128, USA.*

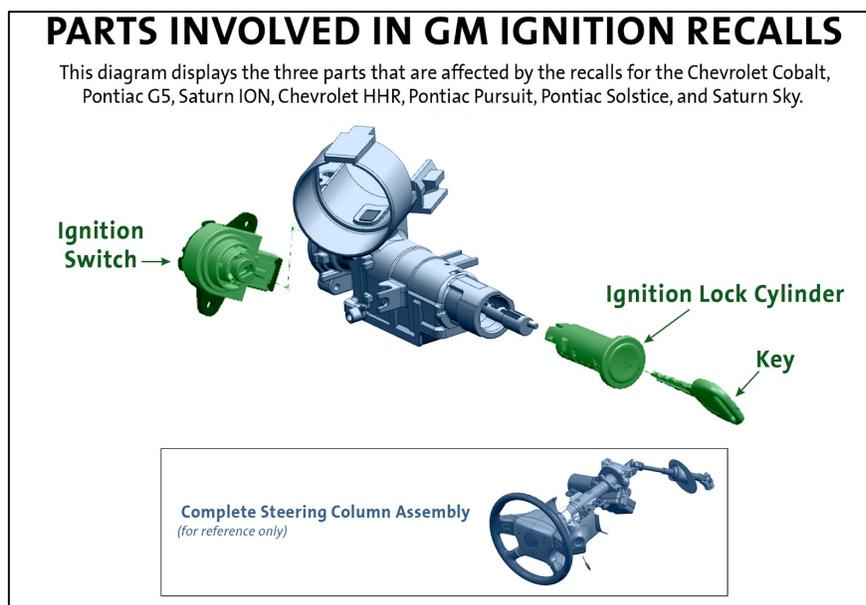
The GM ignition switch that is at the center of their current recall was originally built with the ease of use in mind. GM had received multiple complaints that their ignition switches from previous years were too hard to turn. In an attempt to make it seem like the driver was in a European sports car, the early 2000 models would have an ignition switch that was easier to turn. Figure 1 shows a diagram of the complete ignition module, highlighting the three main parts that were affected by the recent recall [1-3]. GM didn't realize that the decrease in the torque required increased the chances of the vehicle's power mode turning out of Run into Accessory while the vehicle was on the road.

Fig. 1: Diagram of automotive ignition housing affected by recall.

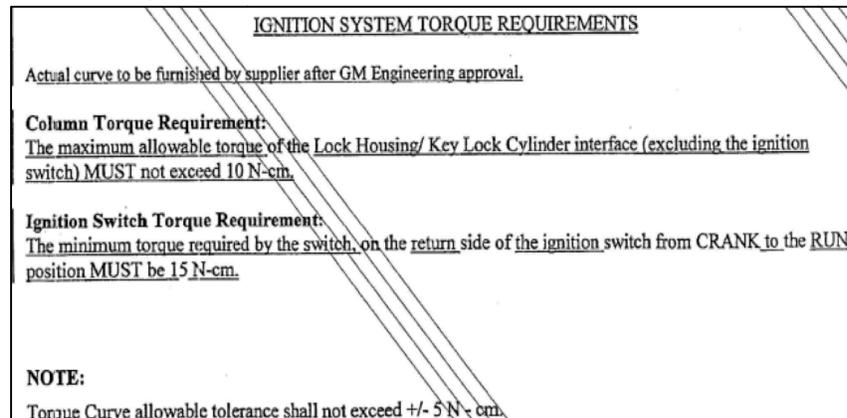
**a) Torque:** One of the major issues surrounding the ignition switch was that the torque did not meet initial requirements. The torque - or force necessary to turn an object around an axis- required for the ignition switch should have been between 10 and 20 N·cm (Newton centimeters). In reality, it was consistently less than 10 N·cm.

Why is torque important? The torque of the ignition switch, along with detents – devices used to hold the switch in place – help to make sure that the ignition switch does not move unless it is intentional. With the torque being lower than what was required, it

was easier to accidentally turn the switch to another state, for example from Run to Accessory.

Fig. 2: GM ignition switch torque requirements [4-6].

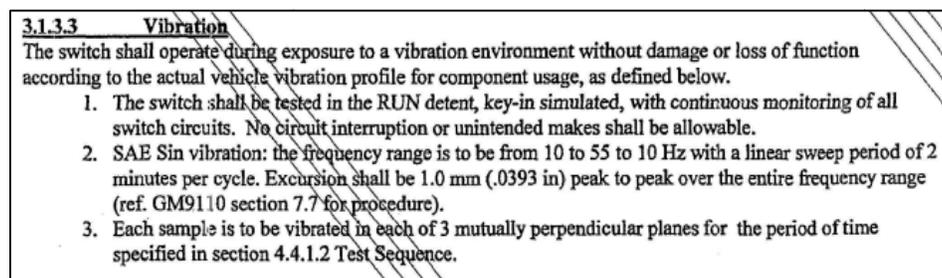
**b) *Vibration*:** another issue with the switch is that it could turn from Run to Accessory during extreme moments of vibration. The specification document describes how the ignition should act when a vehicle is in a high-vibrating environment. Figure 3 shows these requirements. Vibration tests were not listed under the part's performance test section, and the results for these tests do not appear in the Validation Report. However, they are recorded as validation tests within the specifications document, and it states that these tests are run independently.

Fig. 3: GM ignition switch vibration requirements [6].

Vibration added with decreased torque and any heavy object on a key chain could also result in the vehicle's ignition switch turning from Run to Accessory without the intent of the driver. The ignition switch for the recalled vehicles was also designed to remove power from the vehicle's airbags whenever it was in off or accessory modes. This was to prevent the driver and any passengers from getting injured by the airbags in the event an accident occurred while the vehicle was parked. This was a deliberate and known design from GM which engineers on the project should have been familiar with.
