Morphodynamics of Coastal Lagoons: An Analysis of Multitemporal Landsat Images of Segara Anakan Lagoon Area

ABSTRACT

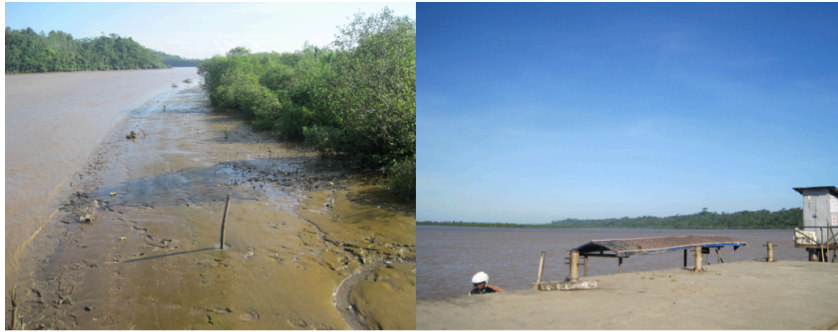
Figure 7. Sedimentation matter brought from Citanduy River

Figure 7 shows that the materials deposited into the SAL consisted of clay, silt and sand. Sediment from Citanduy River contributed to more or less 9,000,000 tons $m^3/year$. Citanduy River located in Western Java, where it flows through two provinces of West Java and East Jawa through Ciamis Regency and Cilacap Regency.

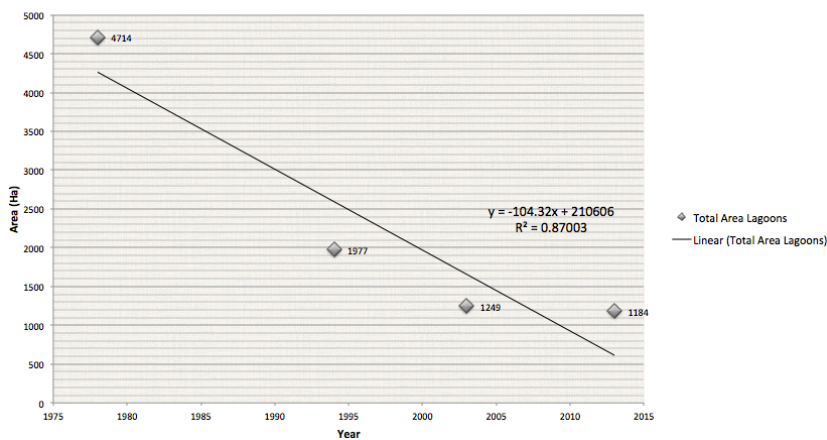
Figure 8. The formula used for the linear regression of the total area of Segara Anakan Lagoon, 1978-2013 (Source: Author's own results, 2015)

Figure 8 is the formula used for the linear regression of the total area of Segara Anakan Lagoon in 1978-2013. It shows how much of a change there is between the beginning of the trendline and the end. Regression lines also give us useful information about the data they were collected from. They show how one variable changes on average with another. For instance, the trends of the area decreased during the development of lagoon, but on the other hands, the area of land accretion was significantly increased.
