An Investigation on High Temperature Erosion Behaviour of Plasma Sprayed CoCrAlY/Al₂O₃/YSZ on Fe and Ni Based Alloys

ABSTRACT

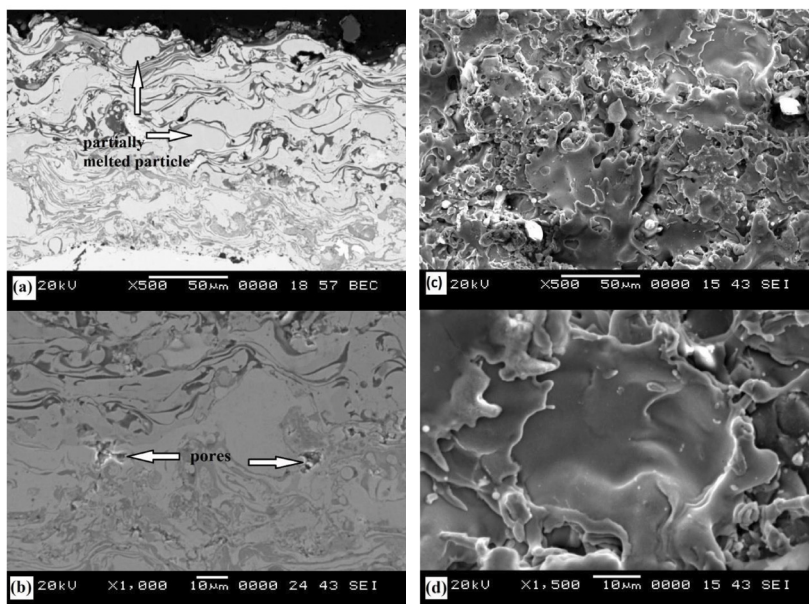
Cross section of the coated sample observed in SEM is shown in Figure 1 and the scale bar in the SEM image shows the appropriate coating thickness ranging from 150 μm to 200 μm . Elliptical splats formed due to the impacts of fully melted and partially melted particles could be seen. Marked small round partially melted particles could also be seen in back scattered image in Figure 1(a). The grey region was found to be Al_2O_3 and white region corresponded to Co rich phases, and pores could also be seen with spotted black colour. Pores present between the boundaries of splats can be observed in secondary electron image as shown in Figure 1(b). Surface morphology of coating, distribution of splats and the splat formed during the molten particle impact are shown in the magnified SEM image in Figure 1 (c, d) and d respectively.

Figure 1. The SEM images of cross section (a, b) and surface (c, d) of as-coated sample.

The plasma spraying technique was used to successfully deposit CoCrAlY/Al₂O₃/YSZ coating on Fe and Ni based substrate materials. Coating with the porosity less than 1.5% and average hardness of 287 HV at 200 g load has been achieved. The results of solid particle erosion at 600°C indicated that the plasma sprayed CoCrAlY/Al₂O₃/YSZ coating has ability to protect both Fe and Ni based substrate at both 30° and 90° of impact angles. The erosion performance is almost similar for coating on both Ni and Fe based since coating properties are the same, unless coating parameter, substrate temperature and roughness are changed. Coating shows better erosion resistance in 90° compared 30° of impact angles. The presence of indentation with raised lips, groves, craters without cracks and erosion loss is more in lower impact angle than higher impact angle, which concludes that the material removal is by ductile erosion mechanism.

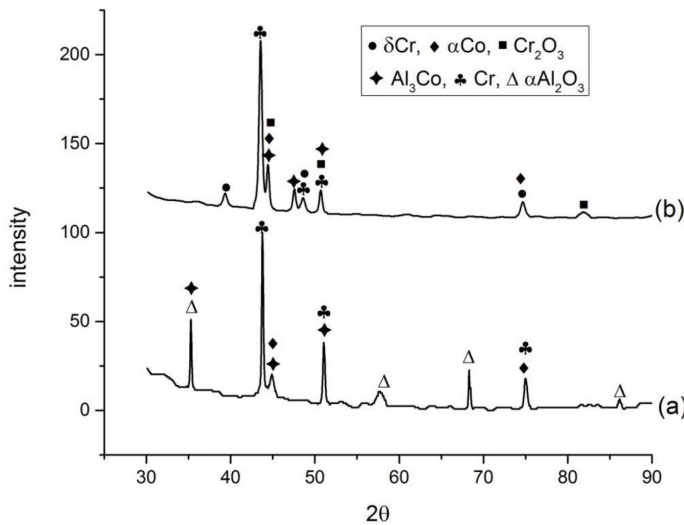
The X-ray diffraction pattern of powder and plasma sprayed CoCrAlY/Al₂O₃/YSZ shown in Figure 2 shows some similar peaks of Cr, α -Co and Al₃Co. Cr and Al₂O₃ are the major phases in the powder with α -Co and Al₃Co as minor phases having low intensity peaks. Cr oxide has been observed in the coated sample, which was formed due to the occurrence of oxidation during in-flight time, and plasma spray process has higher in-flight time compared to other thermal spray process (Wang et al., 2015). The slight amorphisation may occur during the process leading to change in X-ray diffraction pattern peak height and width, which can be observed in the X-ray diffraction pattern.

Figure 2. The X-ray diffraction pattern of (a) CoCrAlY/Al₂O₃/YSZ powder; (b) As coated

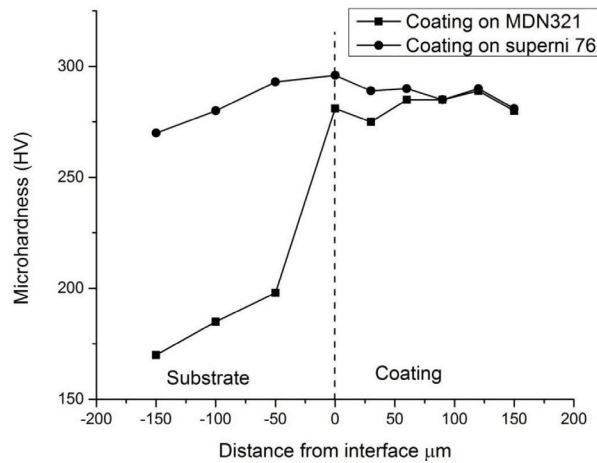
The variation of the microhardness values of the substrate and coating is shown in Figure 3. Both MDN 321 and Superni 76 substrates obtained the hardness value of 185 HV and 280 HV respectively. The CoCrAlY/Al₂O₃/YSZ coating shows the hardness value of 285 HV.

The increase in the hardness of substrate can be observed near the interface because of work hardening effect during the sand blasting prior to plasma spray process. The variation of the microhardness values of coating across the cross section is due to heterogeneous nature and distribution of Al₂O₃ in CoCrAlY matrix. Similarly, Praveen et al. (2015) reported that the heterogeneous nature of Plasma Sprayed Al₂O₃ with Ni based powder coating with the microhardness value of 673 HV with the load of 300 g.

Figure 3. Microhardness variation along the cross section of coating and substrates.

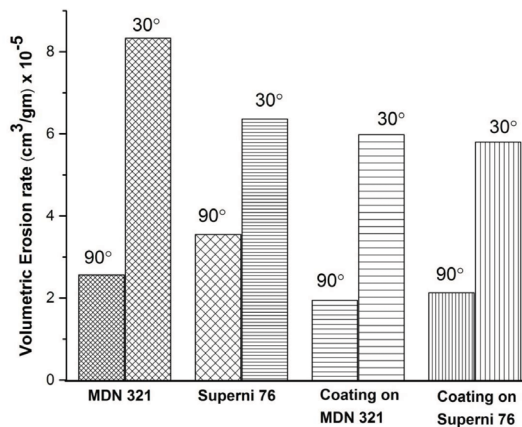
The volumetric erosion rate of coating on two substrates with different impact angles of 90° and 30° is represented in a bar chart in Figure 4. At both 90° and 30° of impact angles, the coated samples showed better erosion resistance performance on both Ni and Fe based alloy substrates. By quantifying the volumetric erosion rate, it is clear that coating shows better performance at 90° compared to 30° impact angles. In general, brittle coating material undergoes rapid erosion at higher angle than at smaller angle of impact and ductile coating material shows rapid erosion at lower angle than higher angle of impact (Tu et al., 1997). From the above reference, it can be reported that CoCrAlY/Al₂O₃/YSZ coating follows ductile erosion mechanism. Coating shows less erosion volume loss compared to plasma sprayed NiCrSiB/Al₂O₃ (Dallaire et al., 2001; Ramesh et al., 2010) which has same hardphase Al₂O₃. Figure 5 (a, b) shows the cumulative erosion loss in each cycle of 10 minutes; it was observed that steady state erosion took place in last 3 cycles as compared to the first 2 cycles. At 90° of impact angle, the coating on both substrates follows the same sequence, which has less erosion in the initial cycle and reaches steady state during the last 3 cycles. However, the reverse pattern of erosion, followed 30° of impact angle which has higher value of erosion at initial cycle and attained steady state during the last cycles.

Figure 4. Bar chart illustrating volumetric erosion rate at 90° and 30° of impact angles.

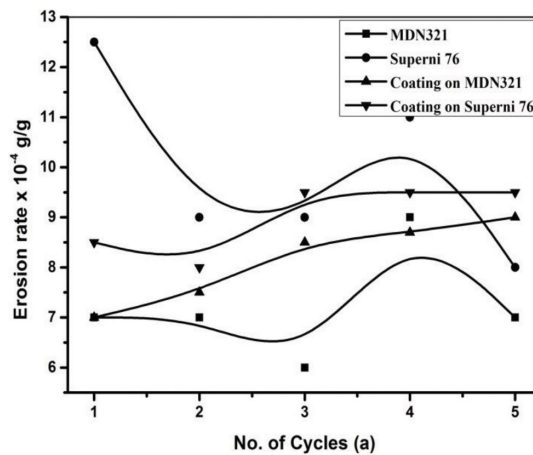
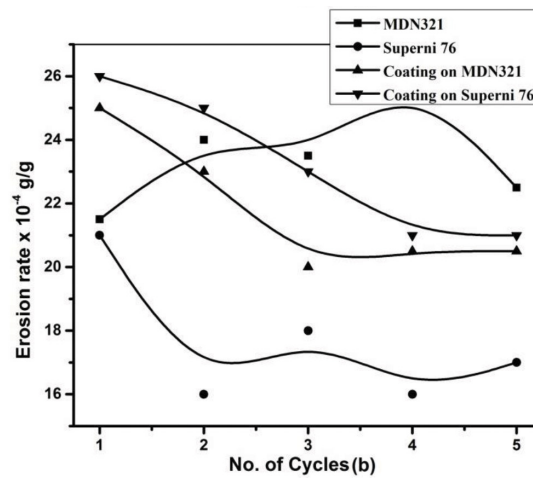
Figure 5. The cumulative variation of the erosion rate with the cumulative weight of the erodent for uncoated and CoCrAlY/Al₂O₃/YSZ at 90° (a) and 30°; (b) of impact angles.

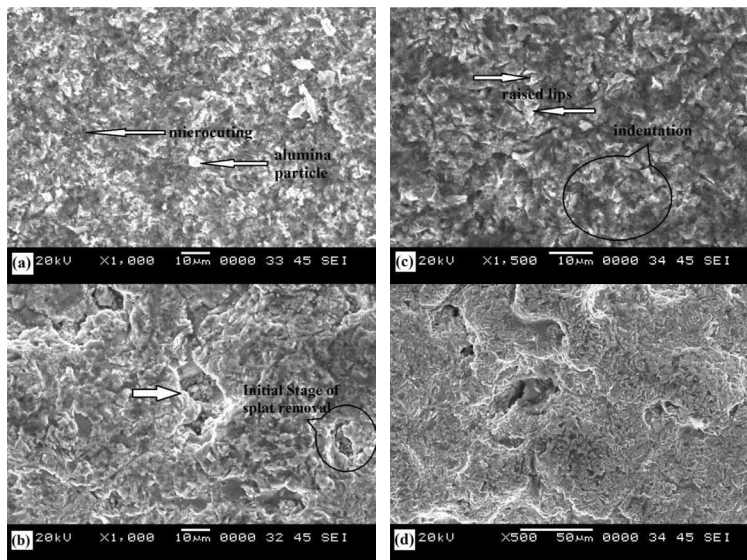
Plasma sprayed CoCrAlY/Al₂O₃/YSZ coating on both MDN 321 and Superni 76 substrates follows a similar erosion mechanism in both 90° and 30° of impact angle. The surface morphology of CoCrAlY/Al₂O₃/YSZ coating at 90° impact angle is shown in Figure 6, which reveals the presence of impact craters, indentation, raised lips and micro cuttings. The indentation on the surface followed by raised lips (Figure 6(a) and (b)), which in turn are plastically deformed from the surface, due to high strain produced by the repeated impacts of erodent particle. Eroder particles, which stick on the surface of coating, can be seen in Figure 6(a). In the feather region, the removal of splats, which forms slightly bigger craters, can be seen. The marked region in 6(b) and 6(d) shows the initial stage of splat removal which loosens the splat boundary by the repeated impact attributed to ductile erosion.

Figure 6. The surface morphology of coating on MDN 321 (a, b) and Superni 76 (c, d) showing erosion on both centre and feather region with impact angle of 90°.

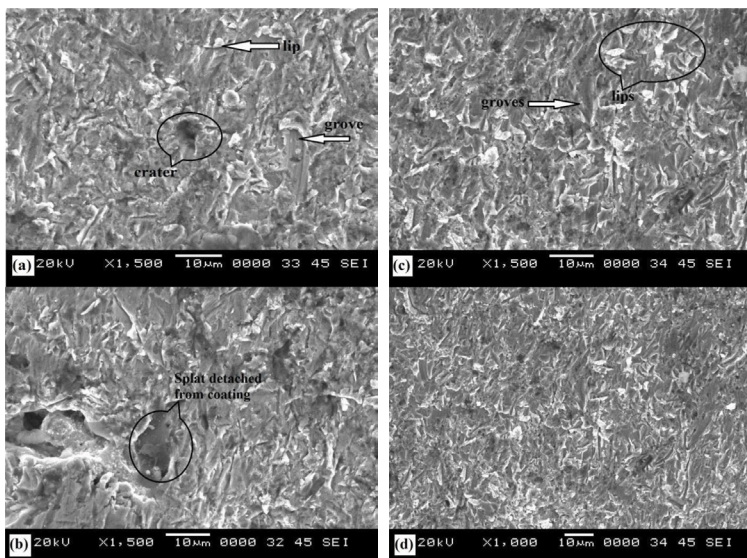
The surface morphology of coating eroded at 30° of impact angle is shown in Figure 7. The presence of grooves and lips represents the material by cutting and ploughing mechanism (Figure 7(c) and 7(d)). Larger grooves are formed on the softer Co-rich region and these grooves are formed by microcutting mechanism. The higher tangential force acts on the hard phases during lower impact angle results in bigger craters, indicating the material removal by chipping mechanism. The number of lips (Figures 7(a) and 7(c)) was observed on the surface, which shows erosion is done by ploughing mechanism.

Figure 7. The surface morphology of coating on MDN 321 (a, b) and Superni 76 (c, d) showing erosion on both centre and feather region with impact angle of 30°.
